TREADMILL NOISE TROUBLESHOOTING GUIDE

FOR
RETAIL AND IPO TREADMILLS

12/20/2022
JOHNSON HEALTH TECH - TCMT
V1

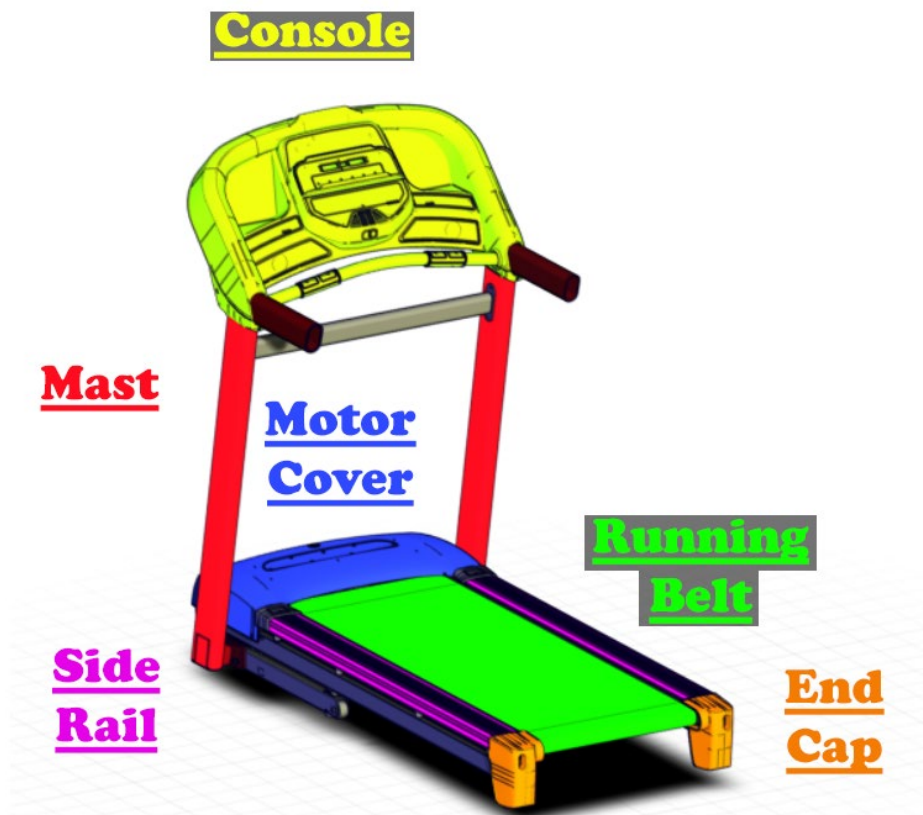
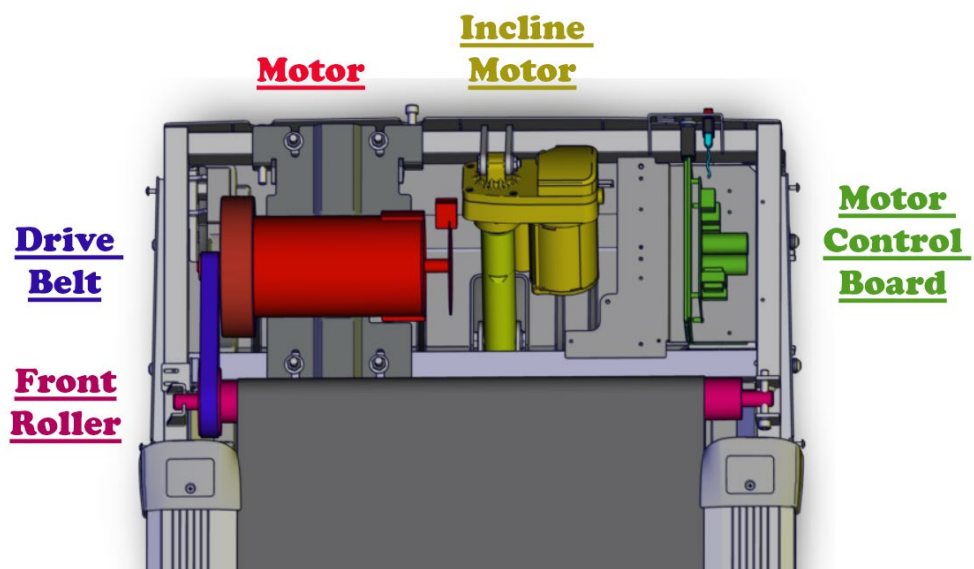
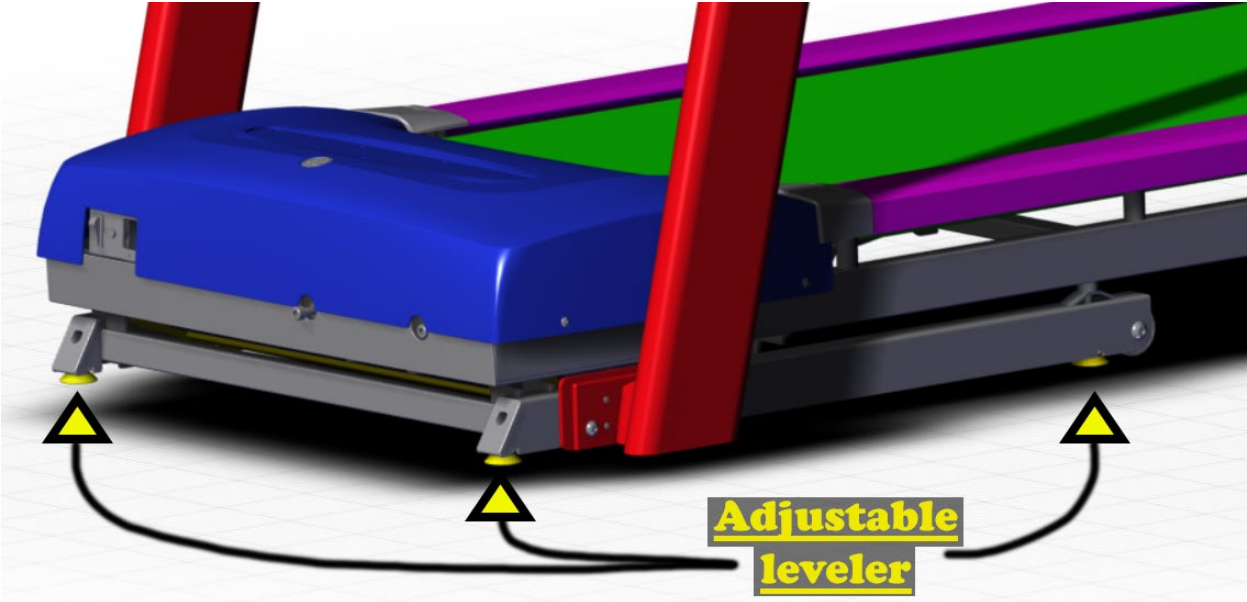
Common Vocabulary

Here are some diagrams to familiarize yourself with the common vocabulary found inside of this document. All diagrams within this document adhere to this color scheme, if you are unsure what the diagram is displaying, reference against these photos for better understanding.

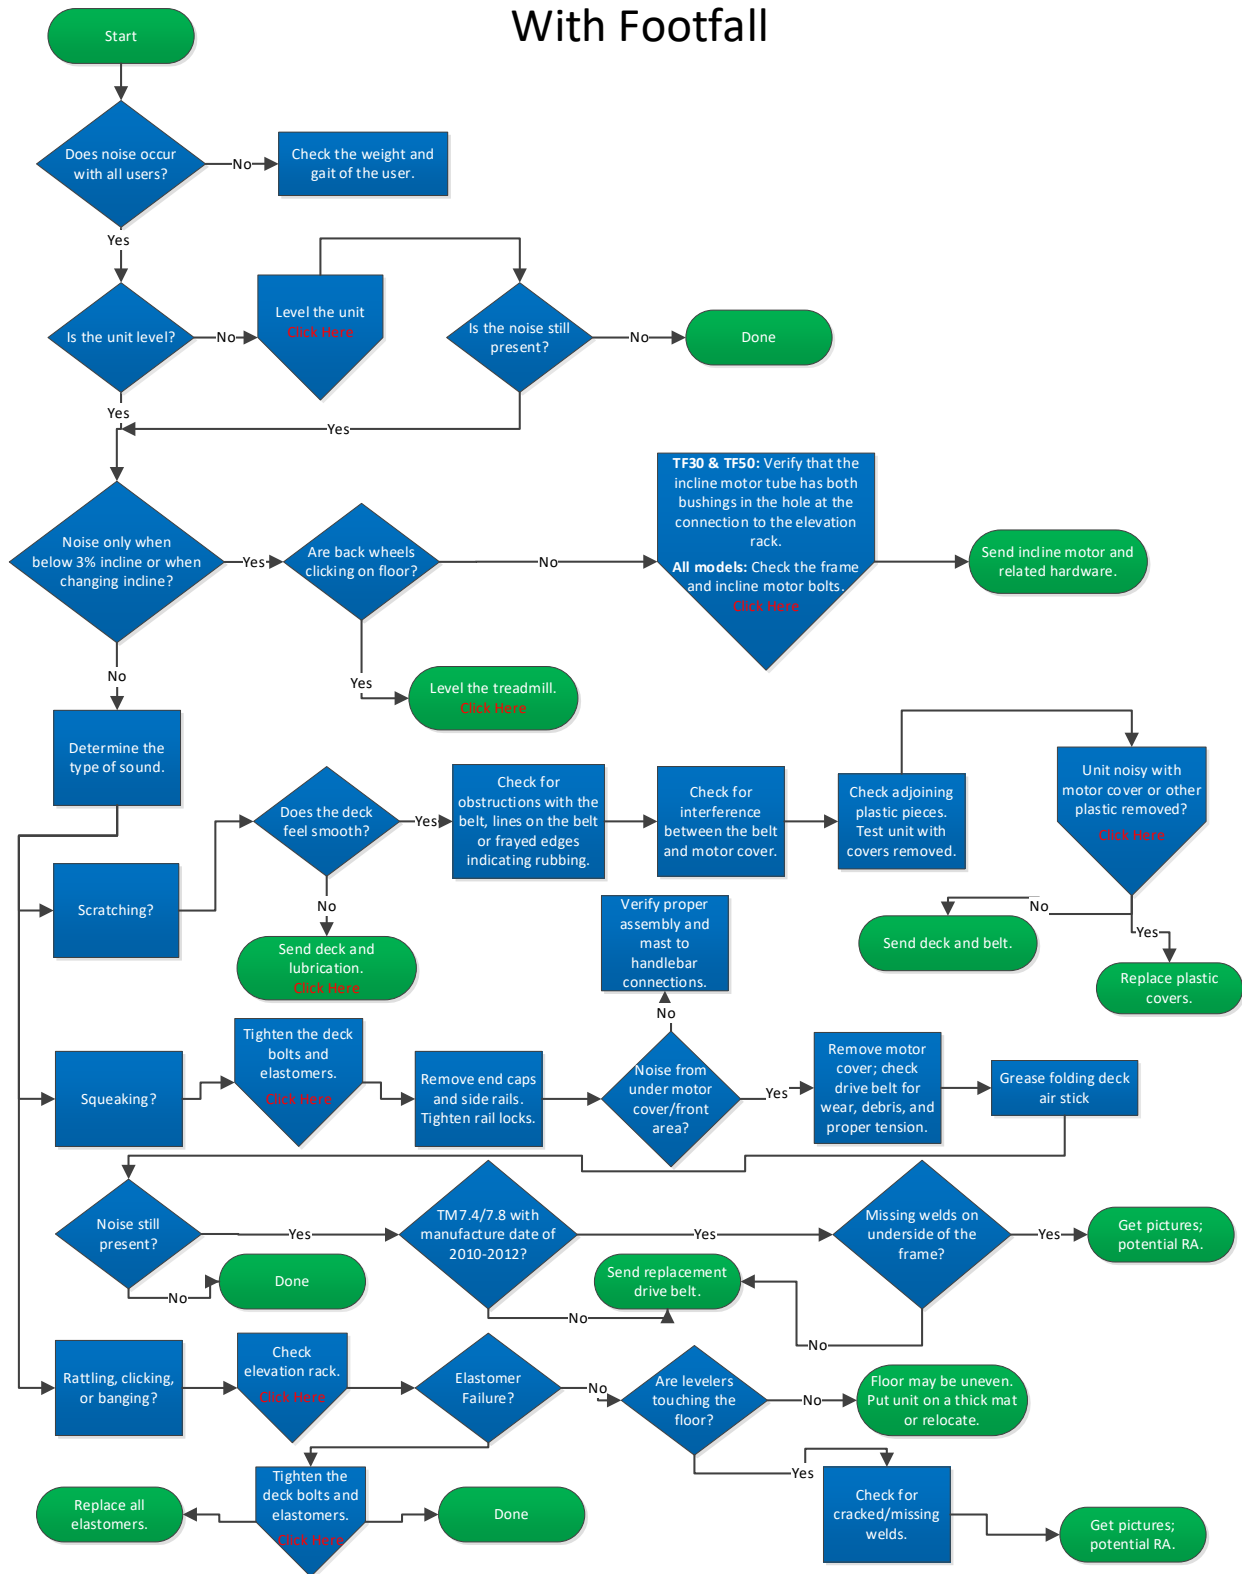
With Footfall

These flowcharts will help to narrow down possible root causes for the noise issues that may be experienced.

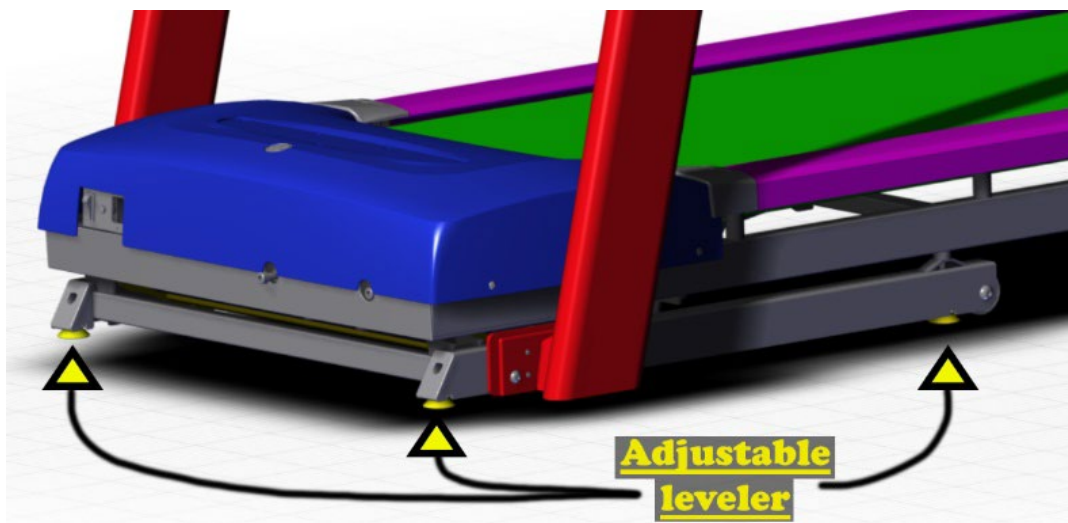
Leveling The Treadmill

Your treadmill should be level for optimum use. Once you have placed your treadmill where you intend to use it, raise or lower one or both adjustable levelers located on the bottom of the treadmill frame. A carpenter's level is recommended. If your treadmill is not level, the running belt may not track properly. A video showing how to level a treadmill can be found [here](#).

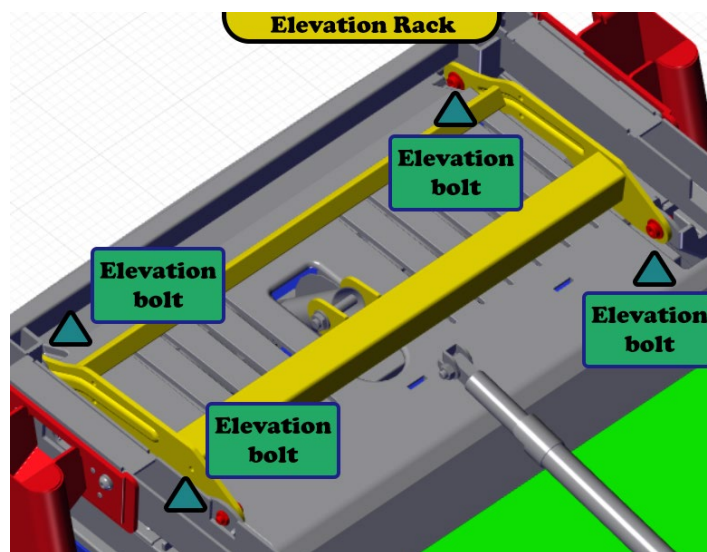
Beneath the motor compartment of the treadmill is the elevation rack. The elevation rack is the frame component that is used in conjunction with the incline motor to increase the incline percentage of the treadmill. Sometimes, the bolts that secure the elevation rack can become loose.

This is a diagram of the elevation rack for a T101-05 treadmill, your model may vary slightly.

1. Place the unit in the folded and locked position. One person should remain at the back of the treadmill to make sure that the deck remains in the folded position.
2. Tighten the elevation bolts.

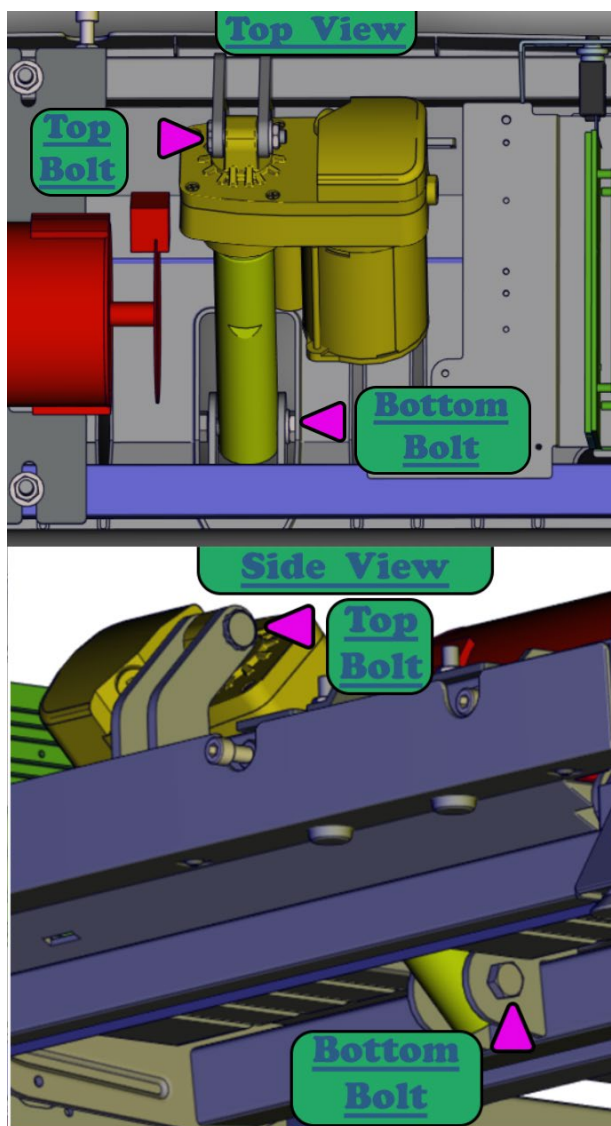
1. Disconnect the unit from power and remove the motor cover.
2. Hand tighten the top bolt and check hardware, make sure the number and type of washers are correct. Apply a small dab of lithium-based grease to the bolt and frame connection cavities. Customers in the United States can view full diagrams by model to verify their hardware is correct at <https://parts.horizonfitness.com/>.
3. Accessing the bottom bolt should only be done by placing the unit in the folded position and requires two people. One person should hold the deck and belt in the folded position when working underneath the treadmill. NEVER place the unit on its side, as the gas shocks can activate with substantial force. Follow step 2 for the bottom bolt.

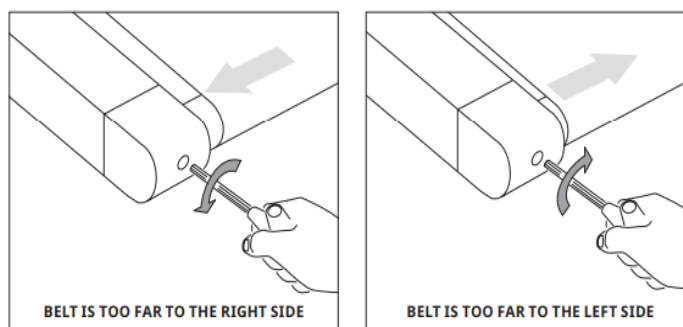
An uncentered belt can cause problems on any treadmill. If the belt does not have equal spacing on both sides, makes a rubbing noise, or is developing wear unevenly on one side – the belt is likely uncentered. This most often occurs after lubricating the belt. The diagram to the right shows how to adjust the rear roller through the end cap. Make small adjustments of half and quarter turns.

1. Press Go on the treadmill and adjust speed to 2mph/3.2kph.
2. Move/adjust the belt by turning the roller bolts clockwise or counterclockwise as shown in the diagram above. Make only small quarter and half turns, large adjustments are typically unnecessary.
3. Watch the belt move to the center of the deck.
4. Repeat until belt is centered on the deck

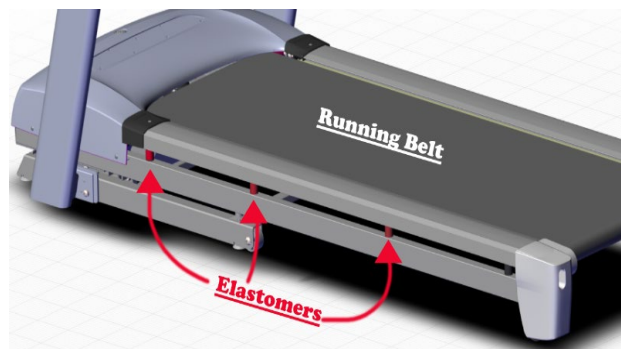
Elastomers are the cushion between the deck and frame, they absorb the vibration and weight of the user as they run on the treadmill. Over time they can become loose or damaged, resulting in noise. On folding treadmills, elastomers can be examined by putting the treadmill in the folded position and viewing them from the underside of the treadmill. When replacing the deck, it is easy to accidentally loosen an elastomer which may impact the quiet performance of the treadmill.

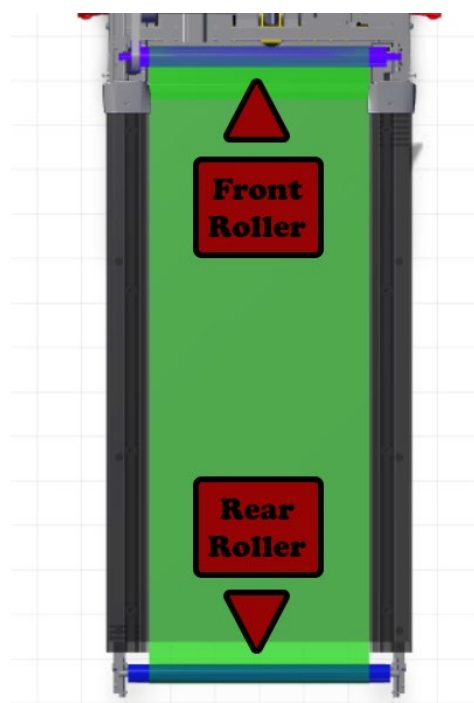
1. Remove the motor cover.
2. Set the treadmill to the lowest possible speed.
3. Carefully run your hand over the length of the front and rear roller. The roller should be completely smooth, any bumps indicate either debris or damage.
4. If debris is detected, follow [this guide](#) for detailed video instructions on how to remove and clean the rollers.
5. If either roller is damaged replace it.

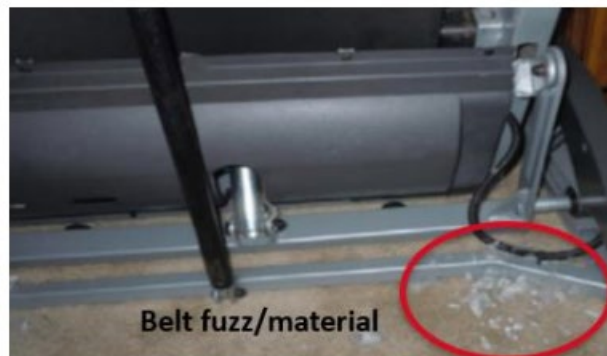
- The most common issue is to see white dust or nylon fabric at the rear of the machine, underneath the deck, and around the rollers – replace belt
- Excess heat from friction could cause the running belt to rip and split in half – replace belt
- Excess heat from friction can cause the underside of the running belt to discolor (dark brownish in color) – replace belt
- Excess heat from friction can cause the top layer of the deck to wear through exposing the wood (brown). This will also damage the belt – replace deck and belt

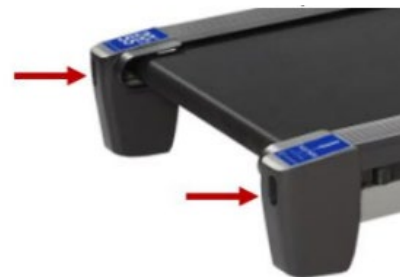
1. From the rear roller, find the 2 roller bolts inside of the end cap (1 on each side)
